# AIR CRUISERS

## ENGINEERING DOCUMENT NUMBER 4208

### EXECUTIVE SUMMARY – EVACUATION SYSTEM ANALYSIS FROM CRASH OF ASIANA FLIGHT 214

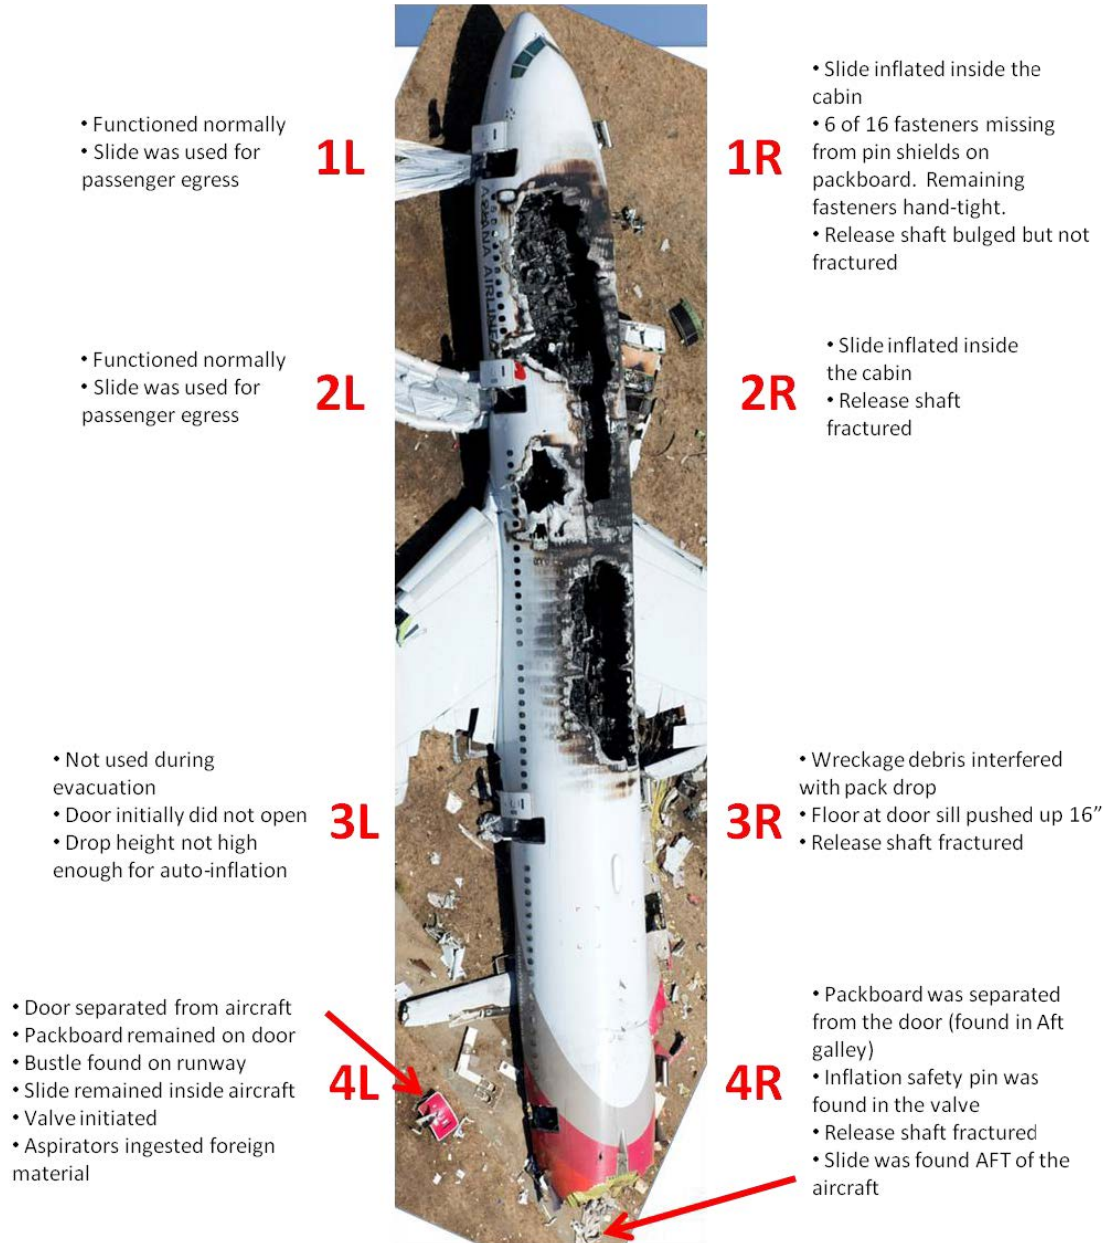
Figure 1. Door-By-Door summary

Figure 1 shows a door-by-door high level summary of the evacuation systems performance from the crash of Asiana Flight 214.

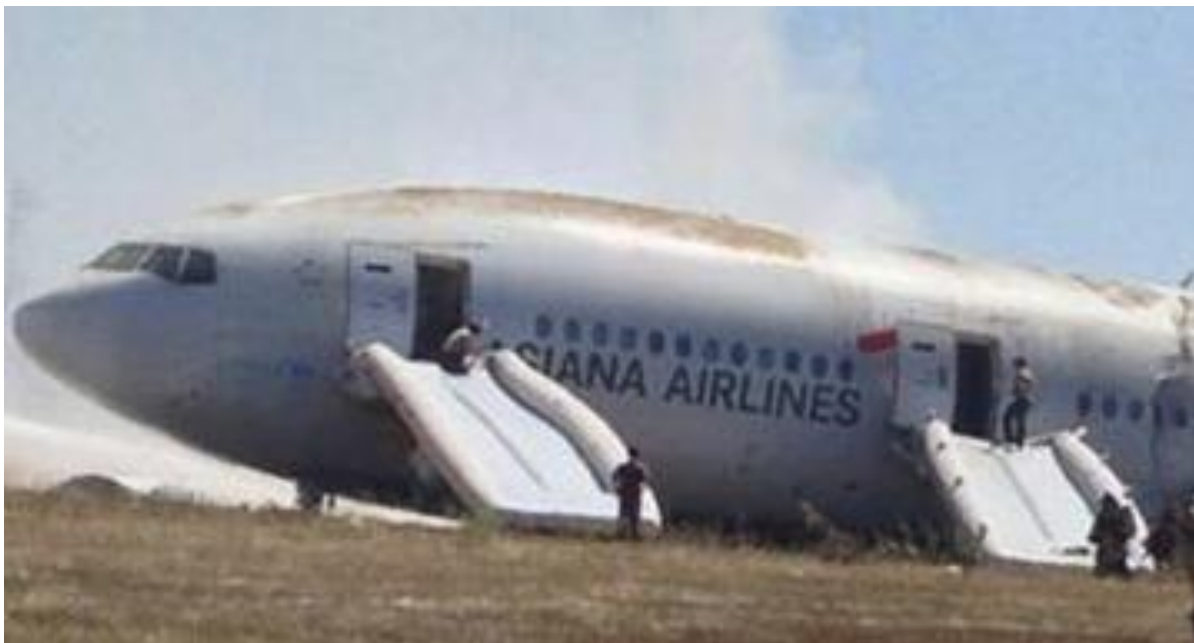
Slide/raft functioned normally and was used by the crew and passengers to evacuate the aircraft. See Figure 2. The slide/raft was also used by first responders to enter the aircraft.

**Figure 2. Door 1 and Door 2 Left Hand**

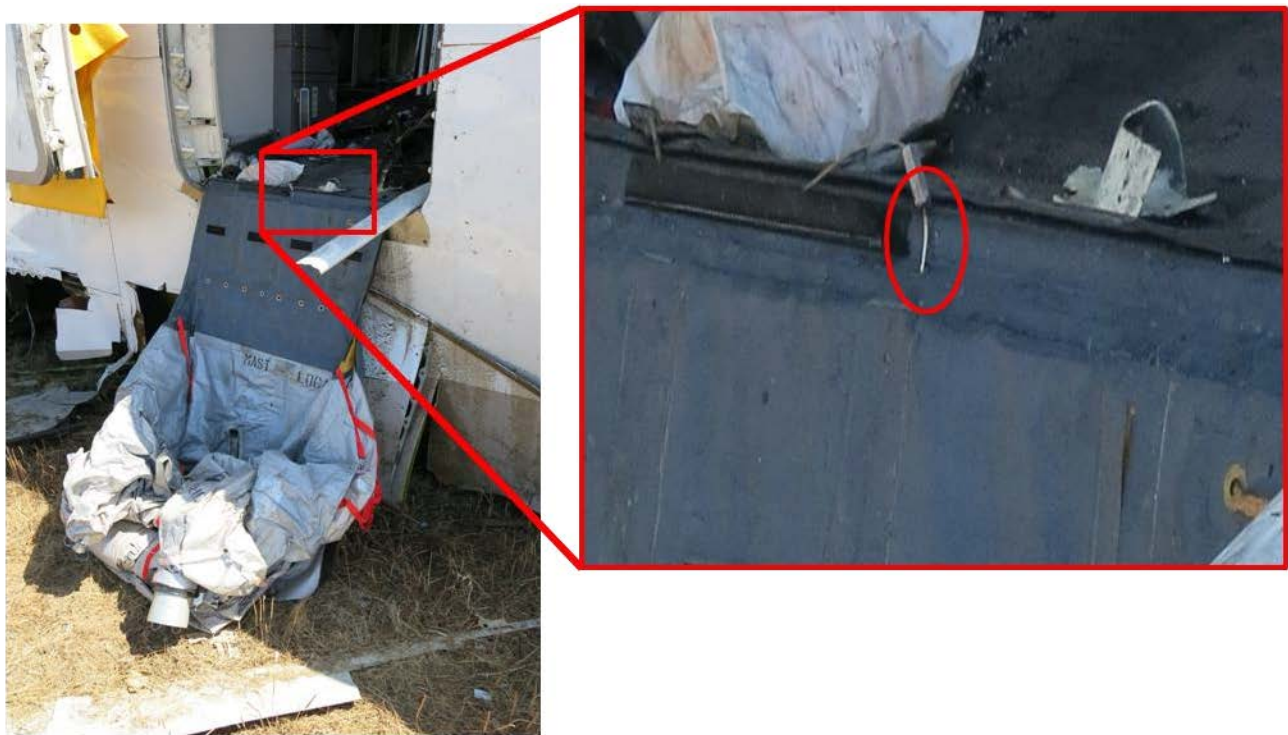
This door was not opened during the evacuation sequence. A flight attendant attempted to open the door but was not able to rotate the handle all the way. At some point in time after the evacuation was complete, the door was opened. It is not known who opened the door or at what time after the evacuation it was opened. The slide/raft did not automatically inflate following the door opening because the reservoir did not fall far enough to tension the inflation cable. The sill height was measured on-scene as 53 inches. The minimum sill height condition tested for qualification of this slide/raft with automatic inflation at this door location was 97 inches. Figure 3 shows that there is slack in the inflation cable at the top of the girt, which indicates that the cable was not tensioned as would be required to activate the valve. If the door had been opened during the evacuation by a flight attendant, he/she would have pulled the manual inflation handle as they are trained to do, likely resulting in a successful deployment and useable slide/raft.

**Figure 3. Door 3 Left Hand Inflation Cable Slack**

It was discovered during teardown of the Door 3 left hand slide/raft that an improper power unit lanyard was rigged to the slide. In addition, a "dummy" lanyard was installed separately into the power unit. This would have resulted in failure of the lighting system to activate. A "dummy" lanyard, also referred to as a shipping lanyard, is provided with every new power unit. Its purpose is to prevent the power unit from self-discharge during shipping and storage, prior to being installed on a slide/raft. This lanyard has no part number identified. The CMM for the slide/raft systems require a part number marked lanyard assembly with a specific length. The "dummy" lanyard looks similar to the part-marked lanyard assembly. Air Cruisers took an action to update the CMM's to specify that new power units are shipped with a shipping lanyard and this lanyard needs to be removed and discarded upon rigging to the slide/raft.

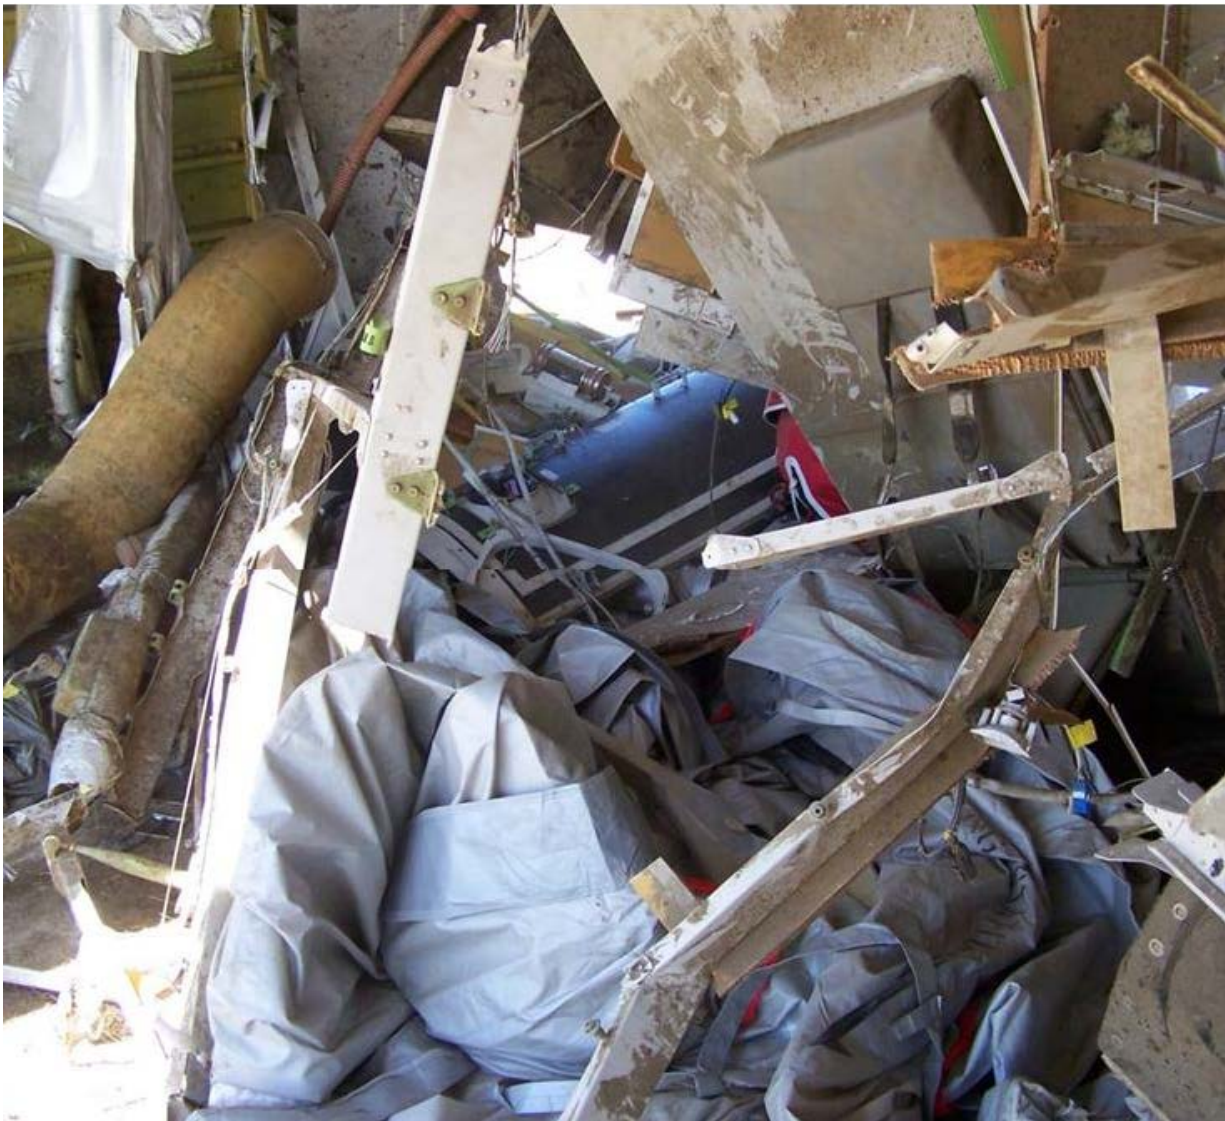
The aircraft door at this location was separated from the aircraft during the crash sequence as shown in Figure 1 and was found thirteen feet away from the door sill. The packboard for the slide/raft remained on the door. The slide/raft was pulled partially aft inside the cabin. The inflation valve was actuated, however each aspirator ingested foreign material, preventing the slide from inflating. The floor below the door sill was missing and the slide/raft was sitting on the ground. See Figure 4.

**Figure 4. Door 4 Left Hand Inside Aft Cabin**

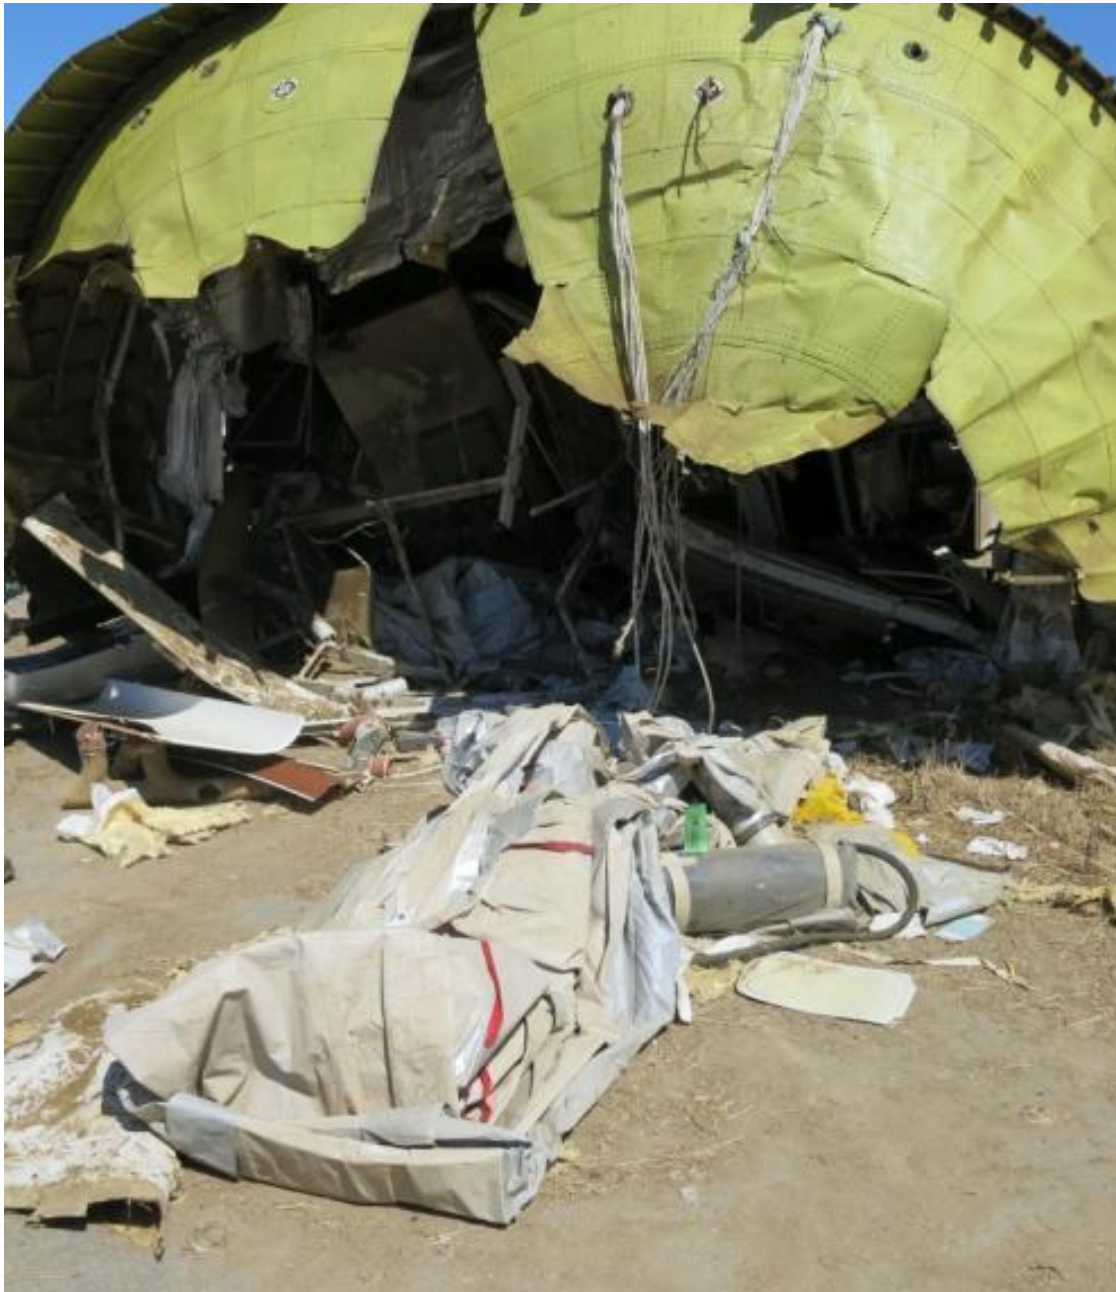
The slide/raft was found on the ground, aft of the aircraft's pressure bulkhead, having been torn away during the crash sequence. See Figure 5. The packboard was found in the AFT galley.

**Figure 5. Door 4 Right Hand Sitting Aft of the Pressure Bulkhead**

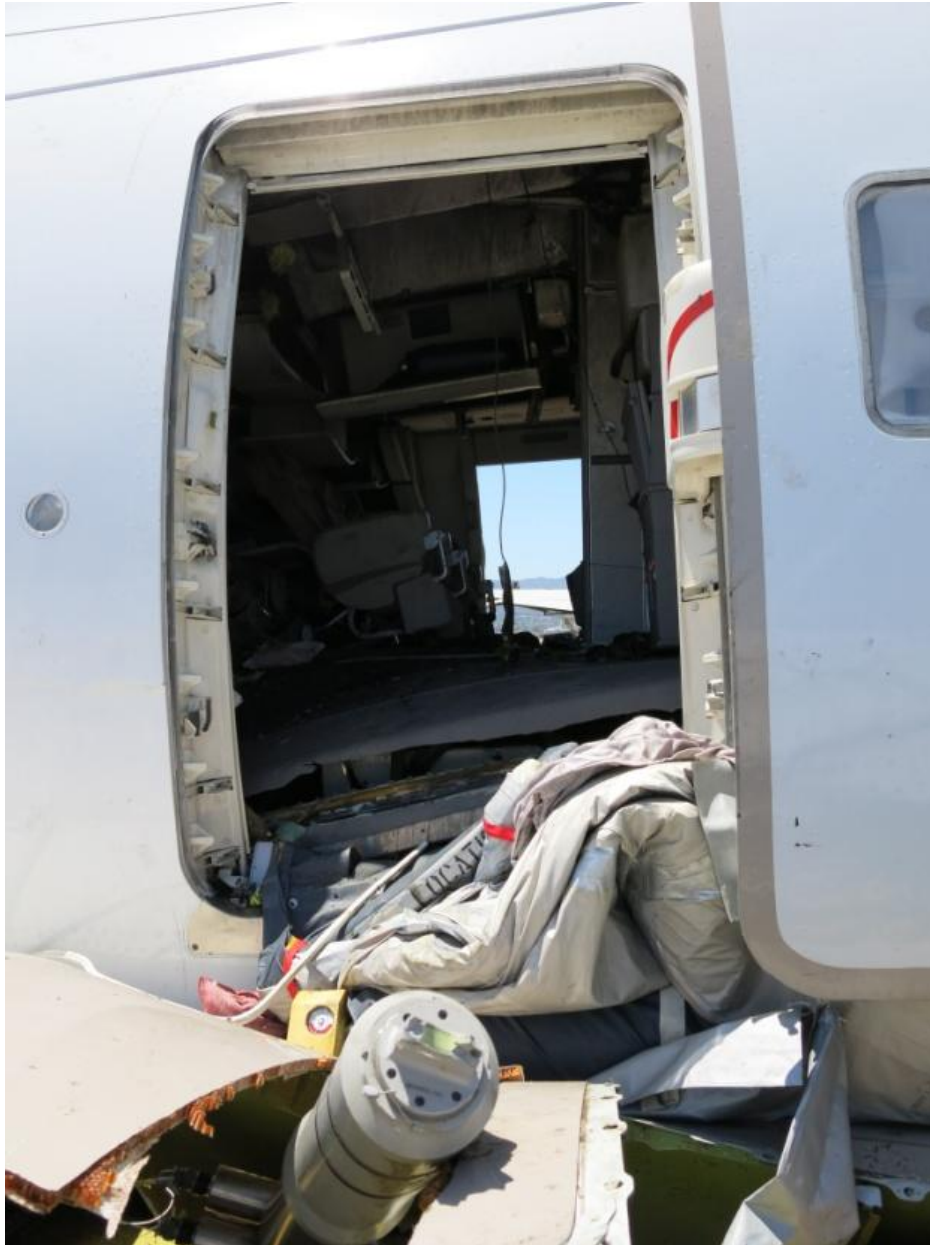
The aircraft floor at the door sill was pushed up by approximately 17 inches during the crash sequence. The door was opened during the evacuation. The slide/raft was not able to drop clear of the door below the door sill due to aircraft wreckage underneath the fuselage. This prevented the slide/raft from being useable. See Figure 6.

Figure 6. Door 3 Right Hand Sitting on Debris

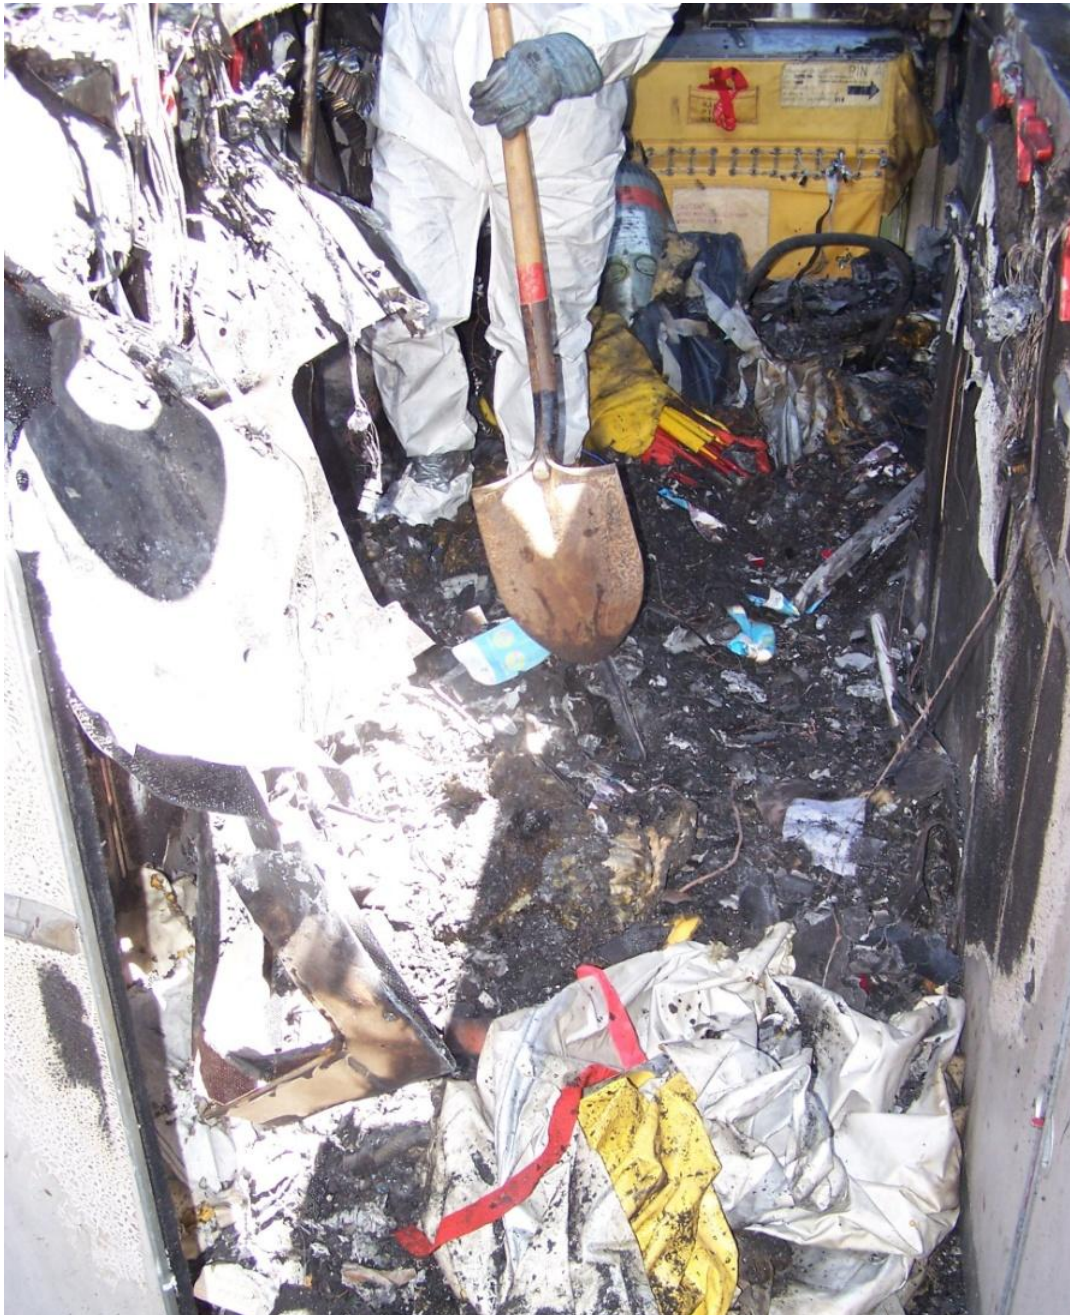
**Figure 7. Door 2 Right Hand**

The slide/raft at the door 2 location on the right side inflated inside the cabin during the crash sequence. See Figure 7. The release of the pack from the packboard occurred due to excessive crash loads, resulting in fracturing of the release shaft. See Paragraph 5.0 for further discussion.

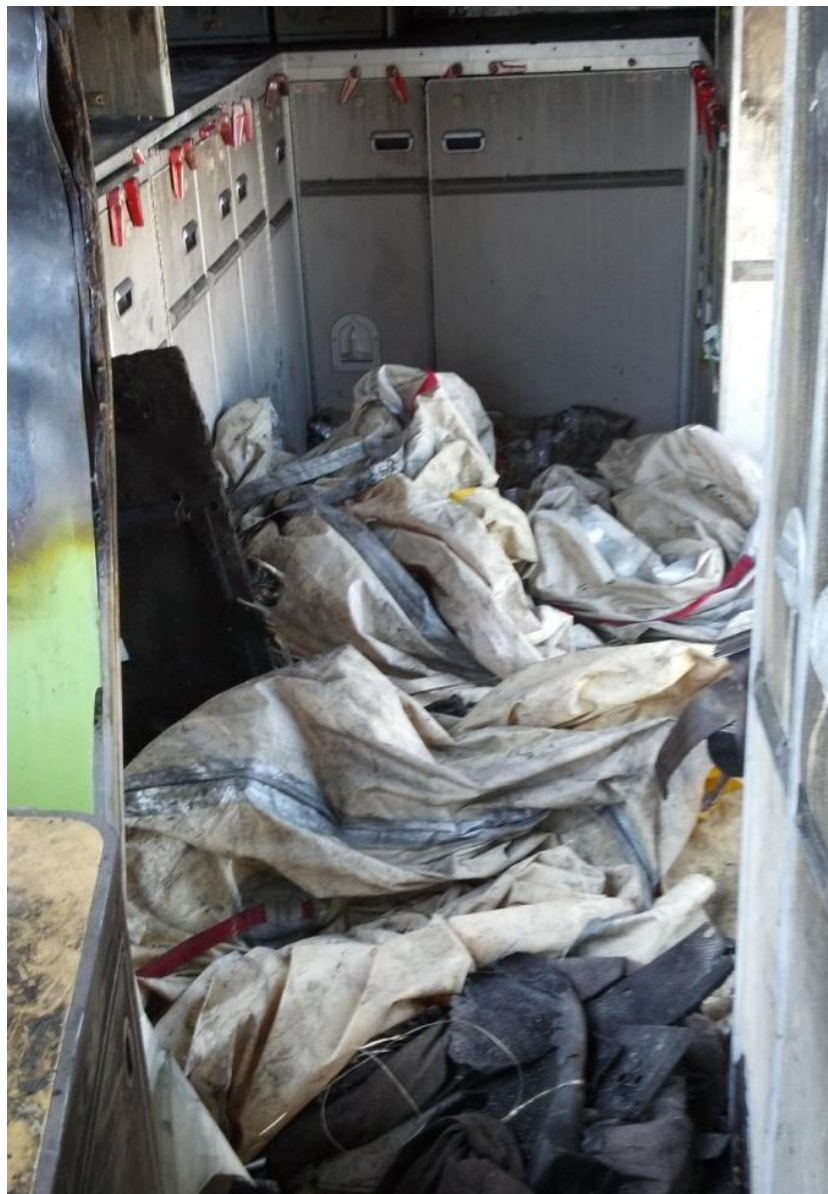
**Figure 8. Door 1 Right Hand**

The slide/raft at the door 1 location on the right side inflated inside the cabin during the crash sequence. See Figure 8. The release of the pack from the packboard occurred due to excessive crash loads, resulting in release of the retention cables from the release shaft. Upon teardown, it was discovered that some of the pin shield fasteners on the release mechanism were loose and/or missing, thus the retention cable ball ends were able to release from the mechanism without tearing the release shaft. See Paragraph 7.1 for further discussion of the pin shield fasteners.

As discussed in Paragraph 4.7, one of the slide/raft systems exhibited missing and loose pin shield fasteners. The fastening consisted of #4-40 screws threaded into tapped aluminum threads with the use of a lockwasher. The subject unit with the missing and loose fasteners had these parts replaced by Asiana mechanics as part of a service bulletin for the release housing. A review of drawings and component maintenance manuals showed that a specific torque value was not specified for installation of those fasteners. Air Cruisers took the action to add a torque value to the assembly drawings as well as the CMM's. In addition, a product improvement was implemented for new production systems to use liquid threadlocker in place of lockwashers.

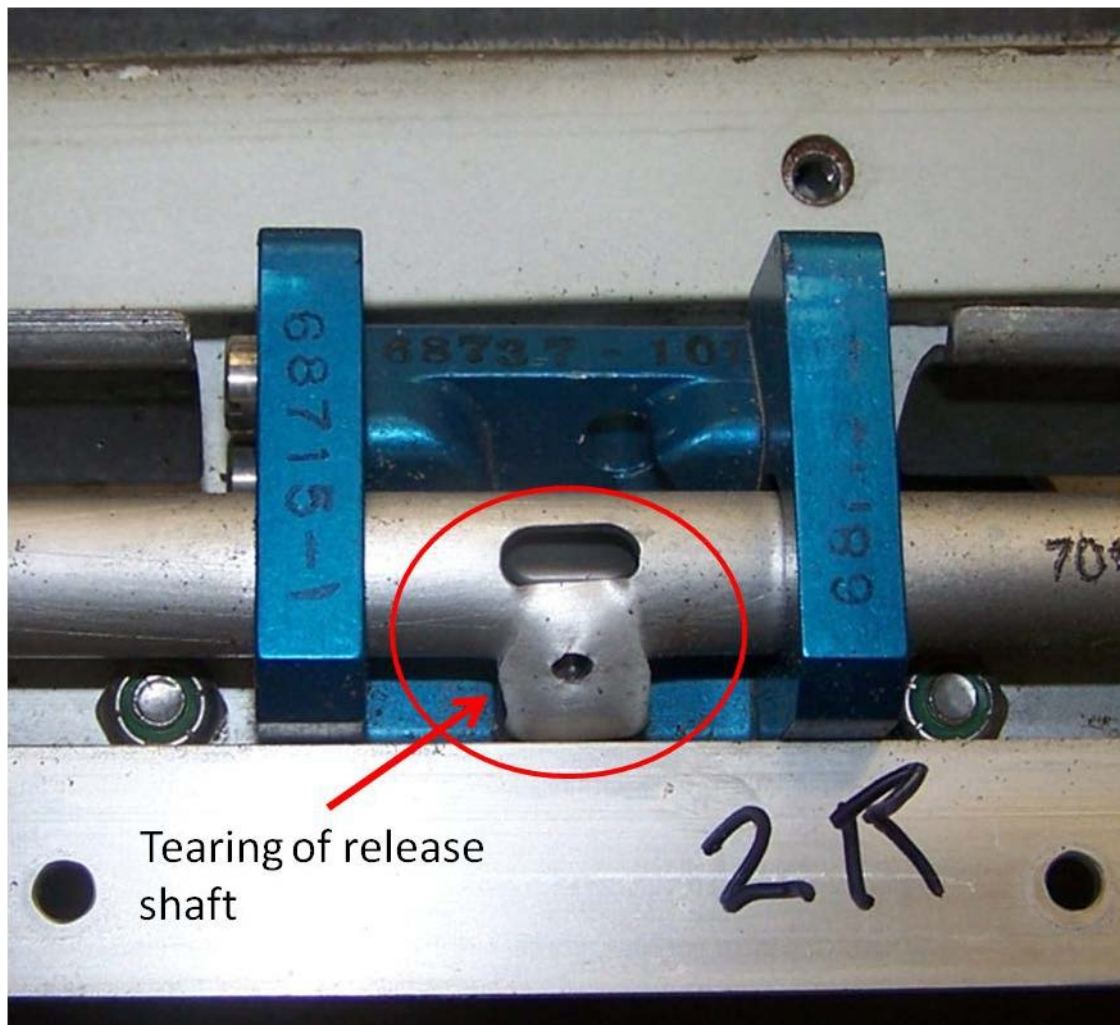
On July 30-31, 2013, a teardown study of much of the evacuation system equipment occurred at Air Cruisers in Wall, NJ with the on-site support of Asiana, Boeing, FAA and NTSB. A primary discovery was that the right side systems suffered from damage to the packboard release shaft. The extreme loads seen during the crash were transmitted from the bulk of the slide/raft pack, concentrating on the upper and lower lacing cover attachments to the packboard. The lower lacing cover is attached to the release mechanism, therefore much of the crash load was exerted on the release shaft. This shaft could not withstand the excessive forces and failed, allowing the shaft to rotate, thereby releasing the cable ball ends from their engagement with the shaft roll pins. See Figure 9 for typical release shaft damage seen on the evacuation systems on the right hand side of the aircraft.

**Figure 9. Typical Release Shaft Damage – Right Side of Aircraft**

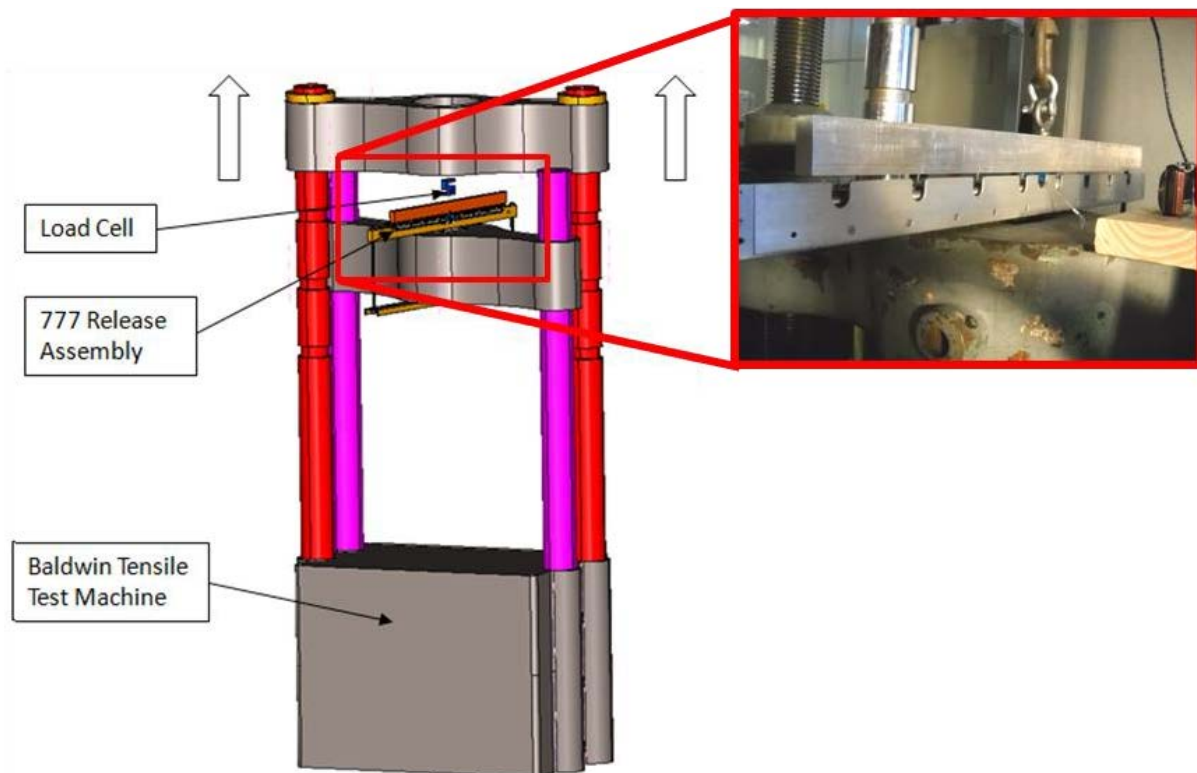
Figure 10. Tensile Test Setup

On November 7, 2013 at Air Cruisers in Wall, NJ, a tensile test machine was used to destructively pull on (6) packboard release mechanisms in an effort to reproduce the damage seen on the right sided evacuation systems and to understand the level of force required to release the packed slide/raft. See Figure 10 for test setup. This testing successfully reproduced the damage. The pull force required to cause the damage similar to that seen on the Asiana Flight 214 right hand systems ranged from 1465 to 1781 pounds. The lowest value was from a release assembly replicating the pin shield fastener condition found on Door 1 Right Hand. Those with properly fastened pin shields had failure values ranging from 1631 to 1781 pounds. When considering the weight of the pack contained within the lacing cover, this force equates to values within the range of 8g's to 16g's. These values only serve as guidance to assist in planning of the acceleration testing as described in Paragraph 6.2 since the tensile tests do not represent the dynamic nature of a crash load.

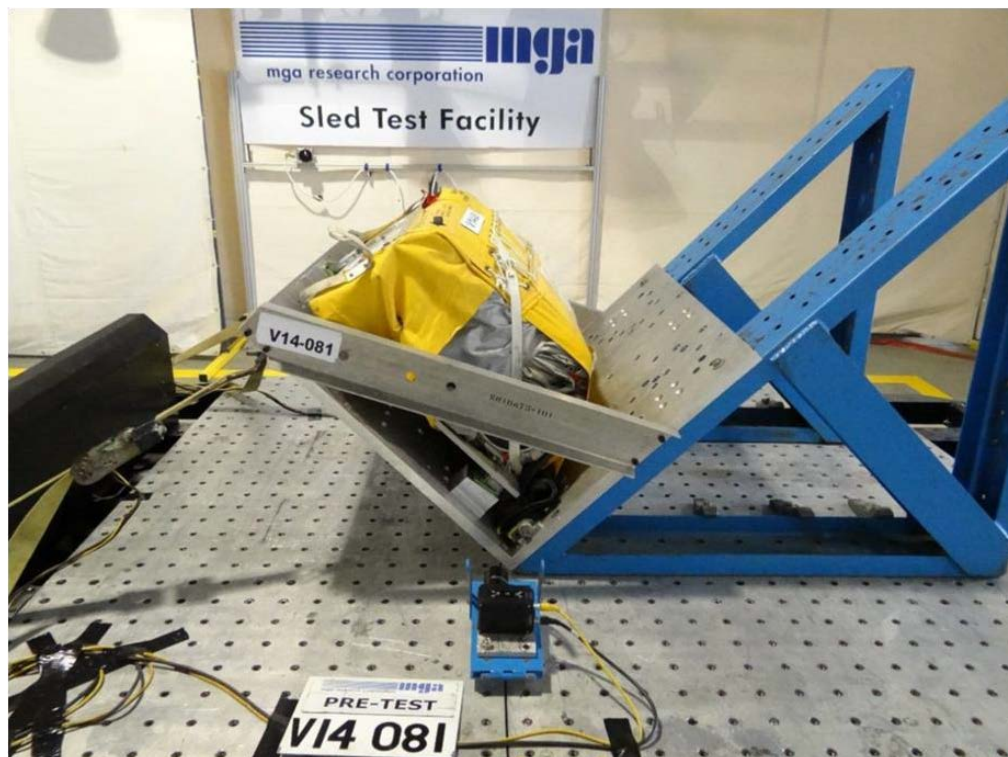
**Figure 11. Acceleration Test Setup (45° Shown)**

On January 21-22, 2014, acceleration testing was conducted at MGA Research in Manassas, VA under contract with the NTSB. The purpose of this test was learn the amount of dynamic force required to cause the slide/raft to release from the packboard. An additional goal was to reproduce the same type of damage seen during teardown of the slide/rafts on the right side of the Asiana Flight 214 aircraft. Testing in the inboard only direction resulted in pack release above 14g's, however the failure mode was not consistent with that seen on the Asiana units. Instead, the inboard only direction resulted in the balls separating from the release cables with no damage seen to the release shaft. Additional testing was conducted in both the down condition as well as the 45° orientation (combining the down and inboard directions). See Figure 11. Tests in these directions reproduced the damage seen on the Asiana Flight 214 units and occurred at values in excess of 12.4g's. This value exceeds the 3g inboard and 6g downward loads as specified in FAR 25.561 (b) as well as the 6.8g downward load as qualified on these 777 systems per Boeing requirements.

The acceleration testing only determines the minimum load required to cause the slide/raft to release from the packboard. It can be inferred that the Asiana Flight 214 aircraft saw at least this level of impact force (12.4 g's) as part of the crash sequence.
